## Analysis of Coastal Abrasion Rate of Laha Village Ambon City Using Satellite Data

<sup>1,2,3,4</sup>Department of Civil Engineering, Pattimura University Ambon

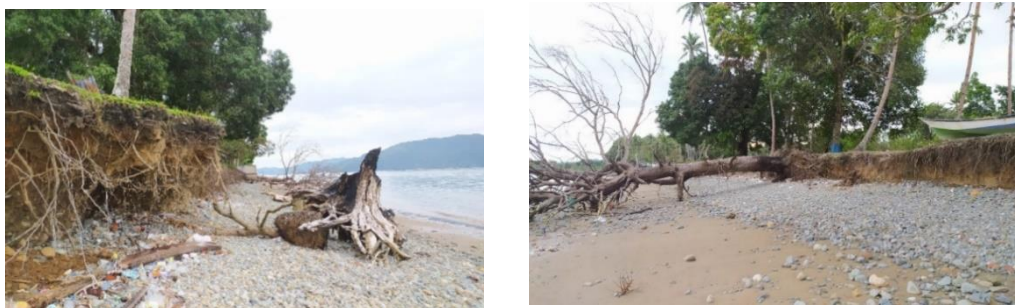
**Figure 1. Trees Falling on the Beach**

The damage at Laha Beach can be seen in Figures 1, which are the collapse of trees on the beach due to abrasion and also the foundations of former buildings on the beach as shown in Figure 2. Initially, the former building was on land and far away from the shoreline but over time, due to abrasion that occurs, the shoreline has shifted past the former building and the collapsed tree.

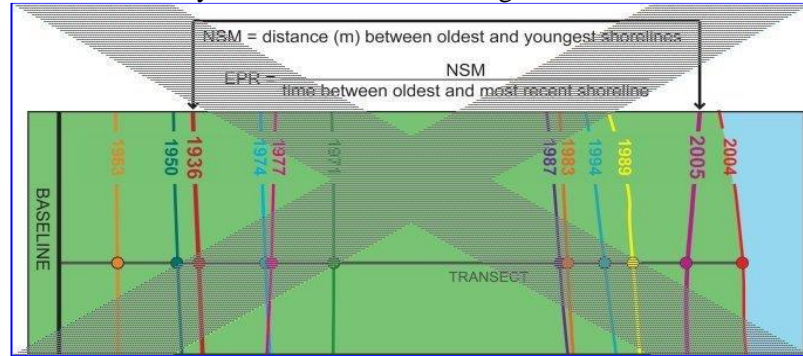
**Figure 3. Trees Falling on the Beach**

The method calculates the rate of shoreline change by dividing the distance between the oldest shoreline and the current shoreline by the time, as shown in Figure 3.

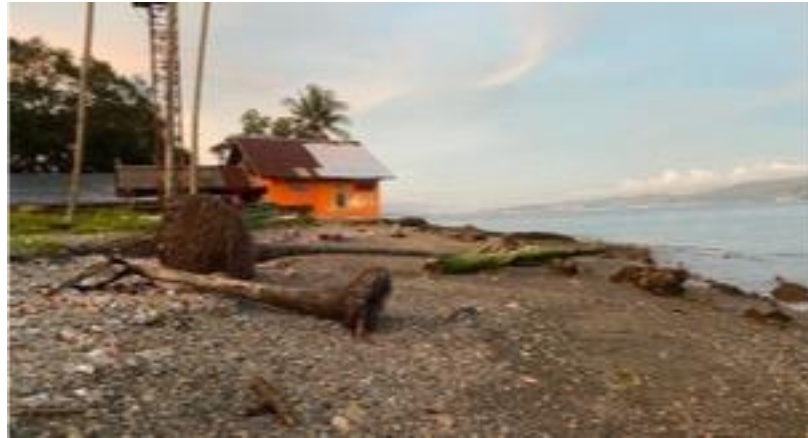
**Figure 5. Beach Abrasion Condition (November 23, 2022)**

This research was conducted along the coast of Laha Village, Ambon City, Maluku Province. The research time is planned within 2 months. The location map and pictures of the current beach conditions are shown in Figure 4 and Figure 5.

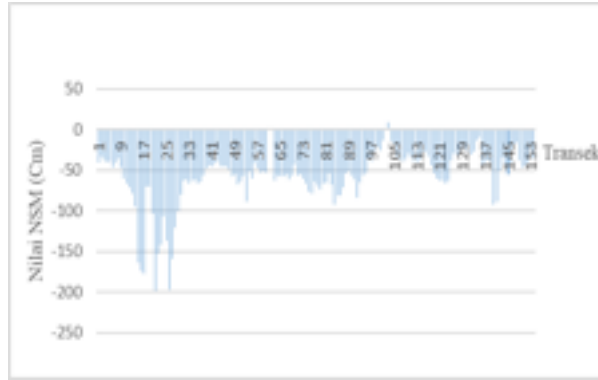
Figure 7, Figure 8, and Figure 9 below are graphs of changes in the coastline of Laha Village using three methods contained in DSAS including NSM, SCE, and EPR. This graph illustrates the level of change and the rate of abrasion on the Laha Village Beach for the period 2013-2022.

Figure 7. Graph of changes in Laha Village Beach 2013-2022 with the NSM method

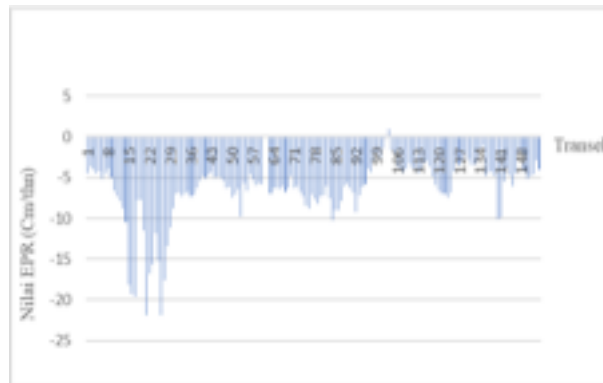
Figure 8. Graph of beach change in Laha Village 2013-2022 using EPR method

Table 1 shows the results of the average area of abrasion and accretion that occurred on Laha Beach. Based on Figure 8, it is known that abrasion and accretion occur at each point where the red location is abrasion, and the light blue color is accretion. Changes in the coastline of Laha village in 10 years of recording data from the above area data show that there have been changes in the coastline with a maximum abrasion area of 113.534 m<sup>2</sup> minimum abrasion 0.01 m<sup>2</sup> with an average value of abrasion area that occurs 89.29 m<sup>2</sup> while the maximum area of accretion is 90.21 m<sup>2</sup> minimum accretion 0.01 m<sup>2</sup> with an average value of accretion that occurs 70.70 m<sup>2</sup> as shown in table 1.

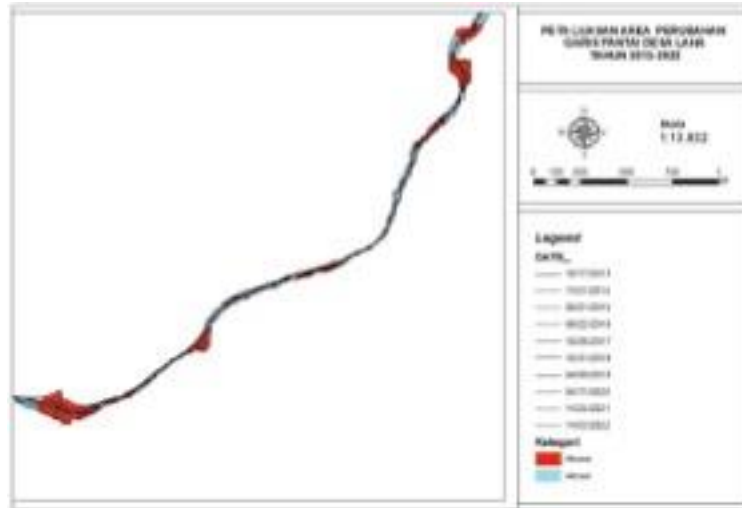
Figure 10 shows the area of abrasion that occurred on the coast of Laha Village in 10 years of recording data.

Figure 10. Laha Village Beach Abrasion Rate Analysis Map for 10 years
