## Slope Stability Analysis Based on Safety Factors on Slope CV. Mutiara Timur in Klampok Village, Tongas District, Probolinggo Regency

### Abstract

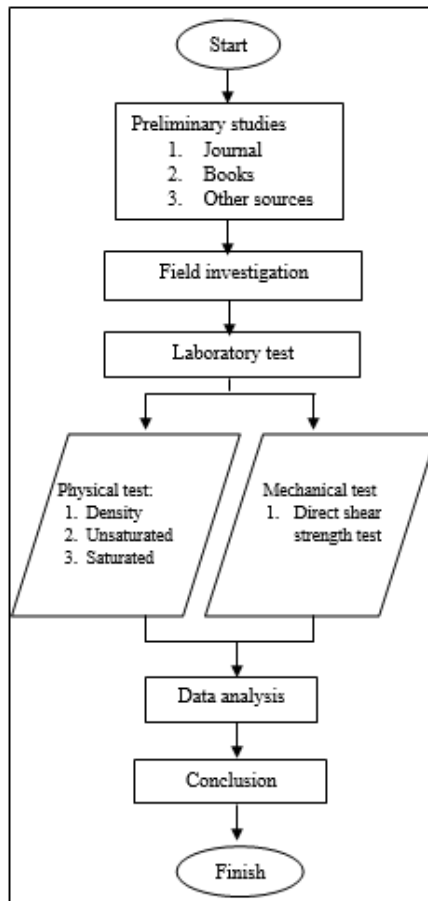
**Figure 1.** Research flow chart

The methodology in this study can be seen in the flow chart as follows:

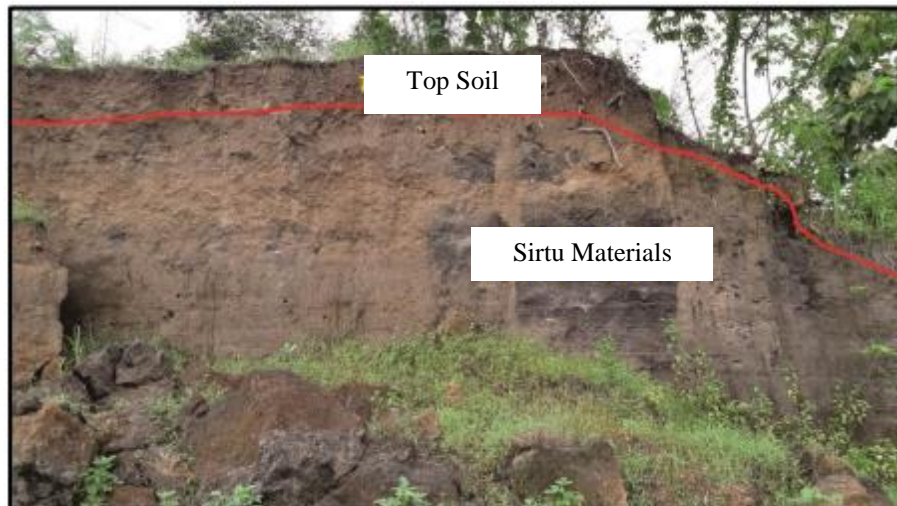
**Figure 3.** The appearance of the topsoil that covers the gravel-sand excavation material

Based on the results of observations of outcrops and cliffs of ex-mining openings found at the investigation site and its surroundings, it is known that the study area is composed of volcanic rocks, more precisely pyroclastic rocks covered by topsoil as thick as  $\pm 1$  meter. The rocks found at the investigation site are composed of blackish gray volcanic material, compact, have a massive structure, poorly sorted, and open-packed, with a sand-sized matrix, while the fragments are subangular-subrounded with a grain composition of gravel, sand and fine grains. silt-clay). Pyroclastic rocks are rocks formed from explosive volcanic eruptions, generally formed in proximal to medial volcanic facies.
